GRACETON DAM

NDI I.D. NO: PA-00279

PHASE I INSPECTION REPORT
NATIONAL DAM INSPECTION PROGRAM

NAME OF DAM: Graceton Dam
STATE LOCATED: Pennsylvania
COUNTY LOCATED: Indiana
STREAM: An Unnamed Tributary of Two Lick Creek
SIZE CLASSIFICATION: Small
HAZARD CLASSIFICATION: Significant
OWNER: Lower Indiana County Municipal Authority
DATE OF INSPECTION: March 18, 1980 and March 19, 1980

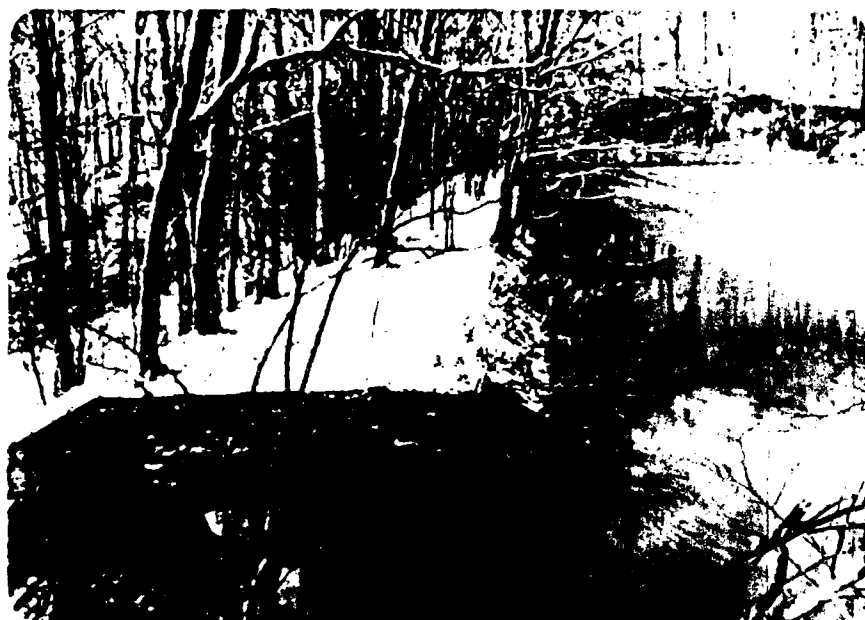
Photograph No. 1
Crest (looking west).

The crest of the dam was surveyed relative to the spillway crest elevation and it was found to be on the order of 0.5 to 0.8 foot below the top of the spillway wall, which appears to be the design crest level for the embankment. The dam crest profile is illustrated in Plate 4. The downstream slope was surveyed and the slopes were found to be reasonably within the design slopes which are 1.5H to 1V above the berm and 2.5H to 1V below the berm level.

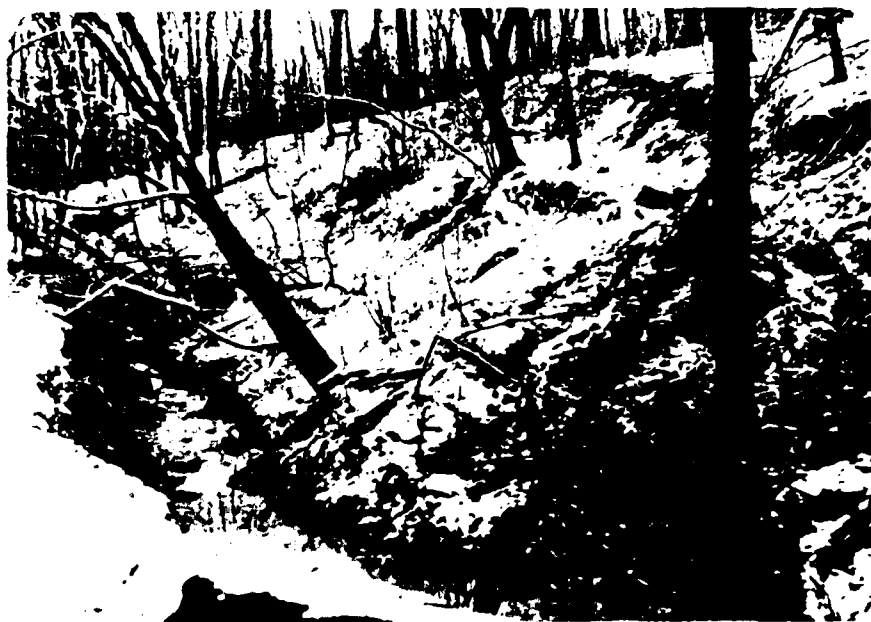
Photograph No. 3

separating the spillway discharge channel from the embankment. An active landslide was observed on the left abutment side of the spillway discharge channel, threatening to block the spillway discharge channel. Two railroad rail sections were found installed in the spillway crest extending from the crest level to the top of the spillway wall. Apparently, these rails were installed with the intention of placing flashboards across the spillway. The presence of these steel sections in the overflow section is considered to pose a potential for the blockage of the spillway with debris in the event of a major flood.

VISUAL EXAMINATION OF	OBSERVATIONS	REMARKS OR RECOMMENDATIONS
JUNCTION OF EMBANKMENT AND ABUTMENT, SPILLWAY AND DAM	There is an active landslide on the left abutment approximately 100 feet downstream from the dam which is threatening to block the spillway discharge channel.	Necessary steps should be taken to prevent blockage of the spillway discharge channel.
ANY NOTICEABLE SEEPAGE	There are swampy areas and ponded water below the toe of the dam. However, no isolated point of seepage was located.	
STAFF GAGE AND RECORDER	None	
DRAINS	None

Shallow discharge channel (looking upstream).
Note tilting trees (landslide).

- a. Conduct additional detailed hydrologic and hydraulic studies to more accurately ascertain the spillway capacity.
 - b. Take the necessary steps to prevent blockage of the spillway discharge channel by the active landslide located on the left abutment.
